ON-SITE AMBULANCE CRASH INVESTIGATION

SCI CASE NO.: CR12001

VEHICLE: 2007 FORD E450 CAB/CHASSIS

AMBULANCE BODY: HORTON TYPE III PATIENT COMPARTMENT

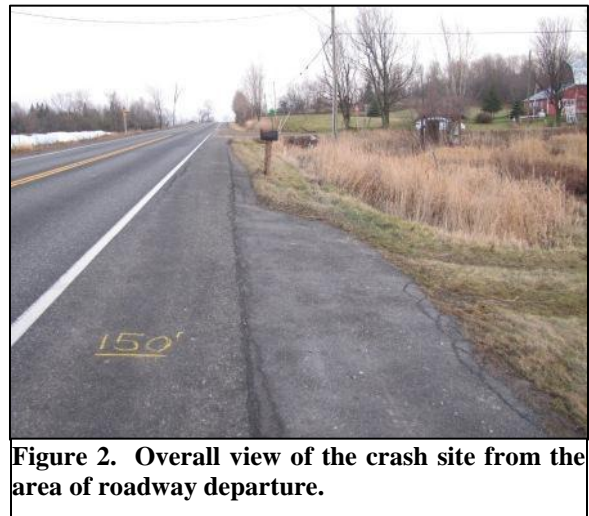
Figure 2. Overall view of the crash site from the area of roadway departure.

A left curve having a radius of curvature of 352 m (1,157 ft) ended 82 m (270 ft) west of the struck embankment. The curve had negative grade of <2 % that transitioned to a sag followed by a positive grade of <2% at the area of road departure. A drainage ditch was located south of the roadway with the ditch bank beginning 4 m (13 ft) south of the south road edge line. The ditch was 2.7 m (9.0 ft) in width with a depth of 1.2 m (4.0 ft). The ditch was dry and was comprised of soft soil in the ditch bottom. The ambulance struck three yielding objects; a mailbox post, a telephone splice box, and guy wire cable. The mailbox was located at roadside while the utility box and the guy wire anchor were located within the ditch bottom. The ditch transitioned into a concrete culvert and an earthen embankment at the T-intersection. The embankment bordered the intersecting street and was oriented perpendicular to the Fords path of travel. The slope of the embankment was positive 52 degrees. The posted speed limit on the state route was 72 km/h (45 mph). The roadway and intersection areas were not lighted. **Figure 2** is an overall view of the crash site from the area of roadway departure.

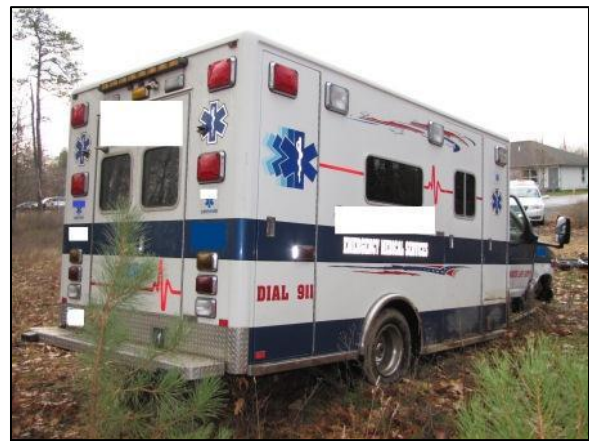
The Type III patient compartment was manufactured by Horton Emergency Vehicles of Grove City, Ohio in August 2007. The Model Number was 553 with a Production Number of 12917 and a Serial Number of J130712917. The unit was constructed of formed aluminum corner posts, side rails and headers with 5x5 cm (2x2 in) aluminum tubing forming the lateral structure of the roof and floor and the vertical structure of the walls. The exterior surfaces were aluminum panels of 3 mm (0.125) in thickness. The interior walls were high density aluminum composite. The exterior dimensions of the patient compartment were 429 cm (169 in) in length, 224 cm (88 in) in height and 244 cm (96 in) in overall width. The interior ceiling height was 183 cm (72 in). The width of the floor was 126 cm (49.5 in). **Figure 5** is an overall view of the patient compartment.

Figure 5. Right oblique view of the Horton patient compartment.

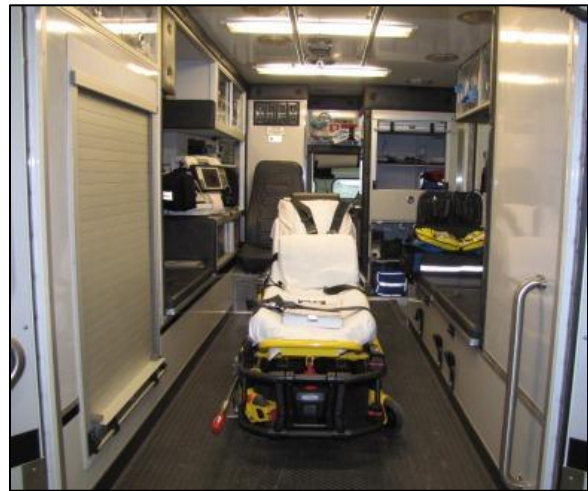
Figure 9. Exemplar ambulance with all equipment displayed.
